Model	Model Code	Year Model	Issue Date
CIVIC 3D	FN1, FN2, FN3, FN4	07, 08, 09, 10	29-11-10
CIVIC 5D	FK1, FK2, FK3	06, 07, 08, 09, 10	Originator Product Technical/QIC HUK (United Kingdom)

## Powered Door Mirrors Do Not Fold Civic 3 & 5 Door Only (LON Information Revised)

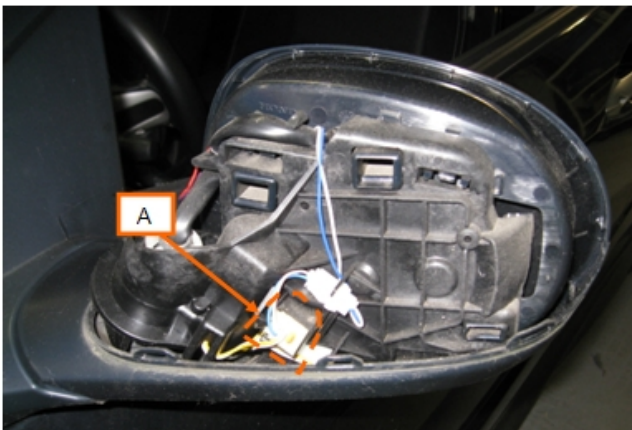
The shut off device within the door mirror fails.

Please refer to image A below for location of the Shut off device.

The shut off device has been modified.

Previously the repair for this symptom would have been to replace the entire mirror assembly, however the shut off device has now been made available as a service part.

If these symptom are encountered, replace the shut off device only.

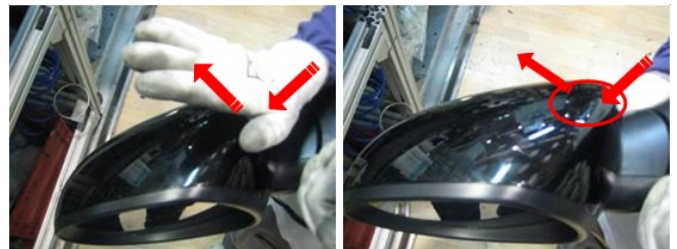
1. Remove the upper casing from the mirror assembly by applying a firm, yet steady, force to the casing in the direction indicated below.

Care must be taken to ensure that there is no damage caused.

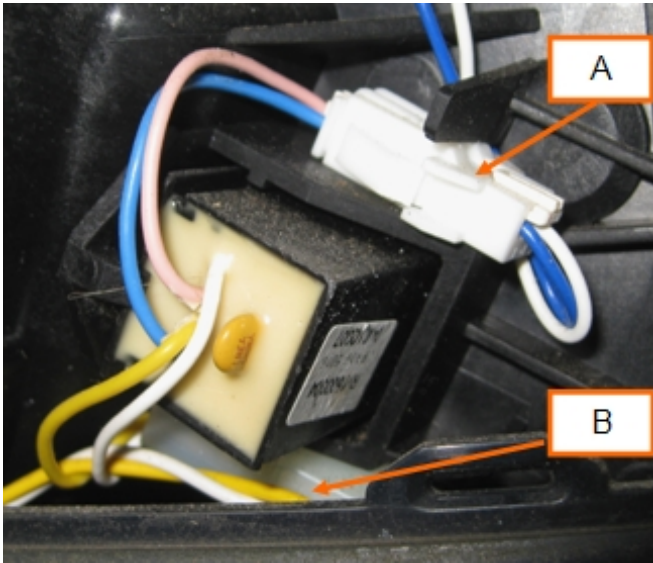
Be aware that there is a harness leading to the indicator lamp which must also be disconnected to allow full removal of the upper casing. See Picture A & B below

2. Remove the upper most 2 pin coupler (A) from it's locating clip, and disconnect the coupler by depressing the locking tab and separating the male and female parts.

Note; Pay attention to the routing of the harness (B) within the mirror assembly as you will need to re-route the harness when you install the replacement shut off device.

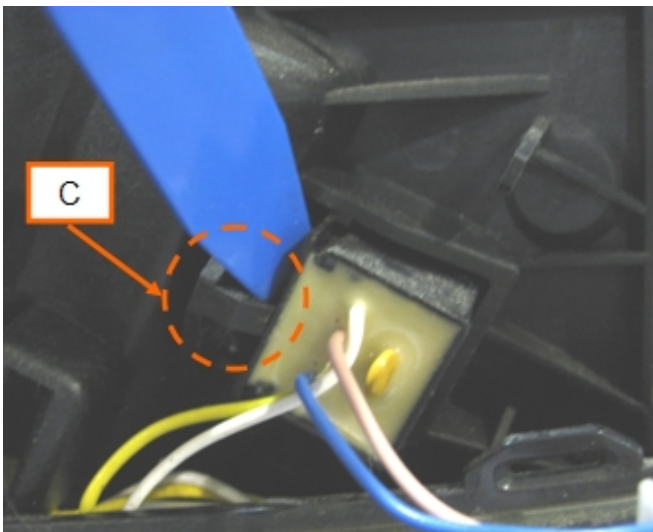
3. Remove the shut off device by using a trim tool to disengage the locating tab and withdrawing it from it's housing as shown in figure C below.

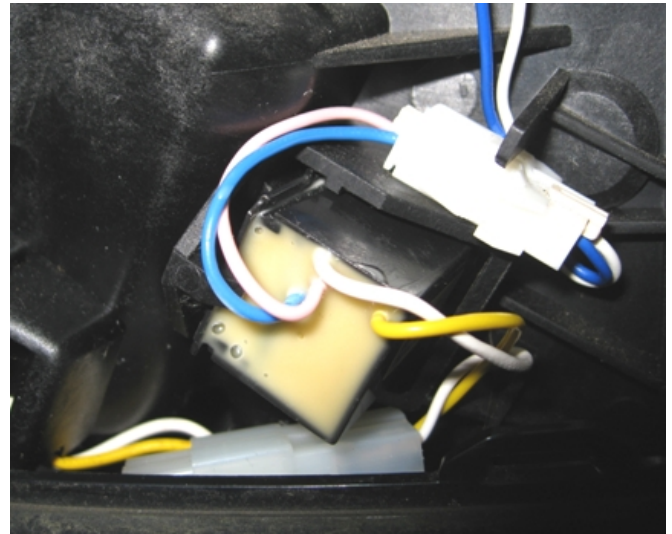
4. With the shut off device removed, disconnect the lower coupler by pulling the two parts of the coupler apart - there is no locking tab on this coupler.

Note: Careful attention to the harness routing & coupler location must be made as you will need to ensure correct routing and location when installing the replacement part.

5. Instal the new shut off device in the reverse order of removal.
